## CASE STUDY

FLOOR FINISH

Hungary

## FLOOR FINISH

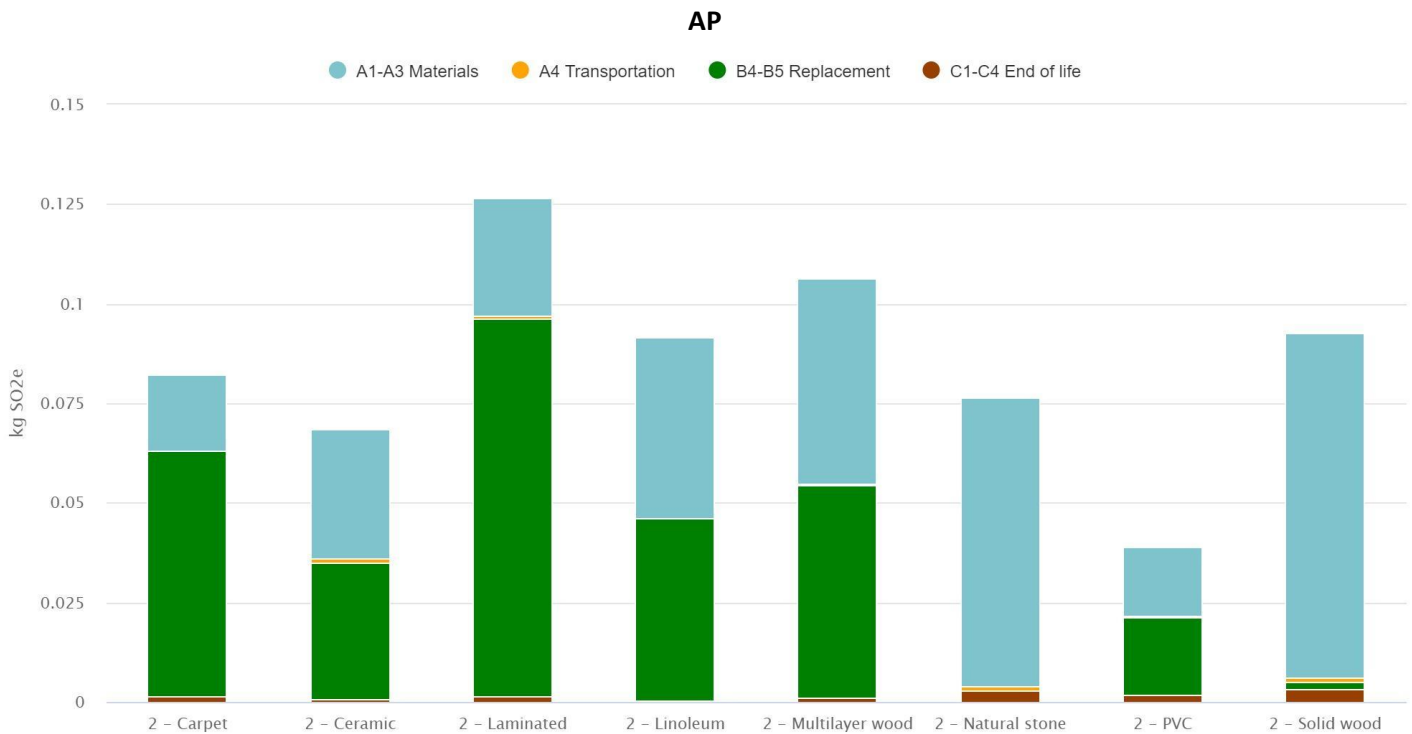
- **Linoleum:** While this option has relatively low GWP, it is less advantageous in other impacts, such as if Acidification and Eutrophication Potentials (AP and EP) are assessed.
- **Solid wood:** This option is less beneficial in other impact categories than in GWP, mainly due to the emissions of drying processes when wood is burned.
- **Stone, Ceramic and PVC:** These solutions have lower results not only in GWP but also in other impact categories. Concerning PVC it has to be highlighted that potential toxic impacts of its life cycle are not quantified in this case study.

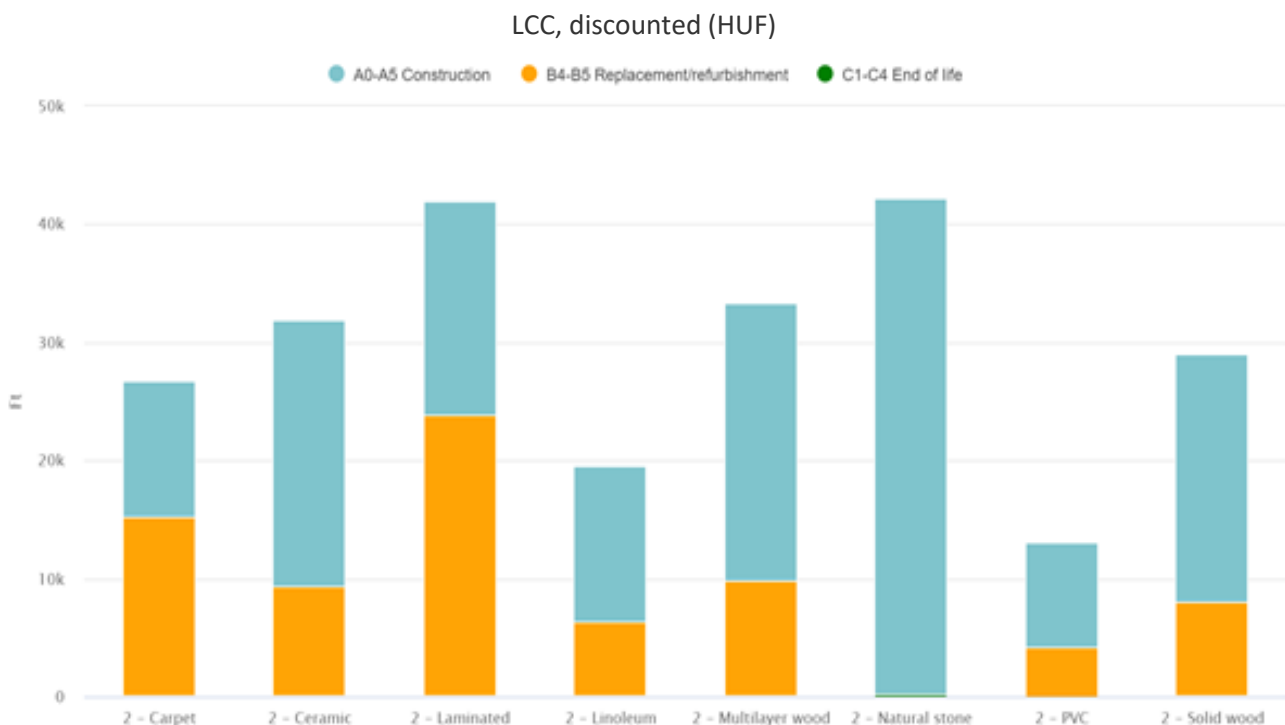
The next figure shows the differences of in the LCC cost of floor finish scenarios by life cycle stage.

In the A1-A5 life cycle stage the natural stone has the highest cost and the PVC has the cheapest cost. But the replacement/refurbishment cost is very variable:

- It is the highest in case of laminated floor finish: it is about 56 % of total LCC, but the cost of replacement is also 56 % for carpet flooring. Both need to be replaced every 15 years, but laminate flooring is more expensive, so there will be a higher life cycle cost under fifty years.
- The natural stone does not have replacement/refurbishment cost.
- The replacement cost is low in case of PVC (22 %) but in another cases (Ceramics, Linoleum, Multilayer and Solid wood) it takes about 20 %, (5000-10000 HUF) depending on price of floor element.
